# 9<sup>th</sup> International Symposium on the Conservation of Monuments in the Mediterranean Basin

## INSPECTION AND DIAGNOSIS OF TIMBER STRUCTURES BY NON-DESTRUCTIVE METHODS

The case study, named Palacete Ribeiro da Cunha, is located in Príncipe Real (Lisbon, Portugal) and his design is from 1877.

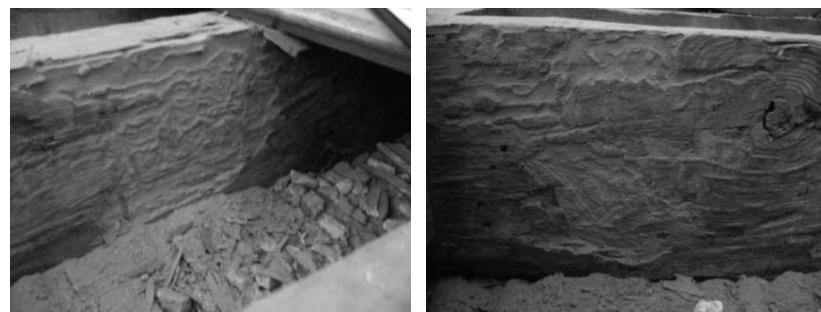
Both bathroom pavement and storeroom roof are well lighted and wide areas, thus easing handling of inspection equipment. On the other hand, storeroom is a poor lighted smaller area, thus increasing difficulty of inspection procedures. Biological damage caused by boring beetles attack in all analyzed areas was verified. Some elements had a rough surface and the presence of sawdust could be verified with a sharp object (Figure 6).

**Figure 43.** Biological damage caused by boring beetles attack

Despite cross section reduction due to biological attack, the effective cross section is still enough for safety. However, for two elements the ratio stress-strength is very close to one, which leads to safety risks if biological attack is not stopped. Therefore, in order to avoid the progress of the biological attack, the application of a preservative treatment is highly recommended.

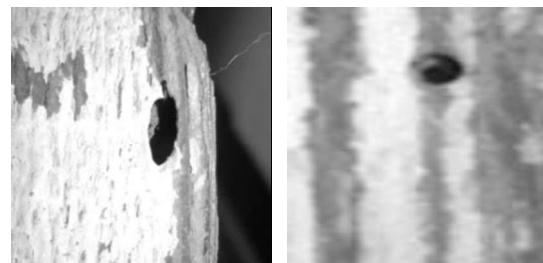
The presence of oval shaped exit holes was confirmed, suggesting the presence of house longhorn beetle, as well as circular shaped exit holes, usually related with common furniture beetle (Figure 7). The exit holes had an approximate diameter of 8 mm for house longhorn beetle and 2 mm for common furniture beetle.

The biological degradation by wood boring beetles revealed more severe near the wall pavement connection. One of the larger joists had an effective cross section reduction of 18,8%. If not properly treated, this state of decay may lead to joist collapse, due to excessive loss of cross section and therefore strength, resulting in safety risks to the residents. In the resistographic profile two weaker spots were detected (A and B), as shown in Figure 8. These weaker areas can be related to biological degradation by house longhorn beetle.

**Figure 44.** Exit holes: house longhorn beetle and furniture beetle

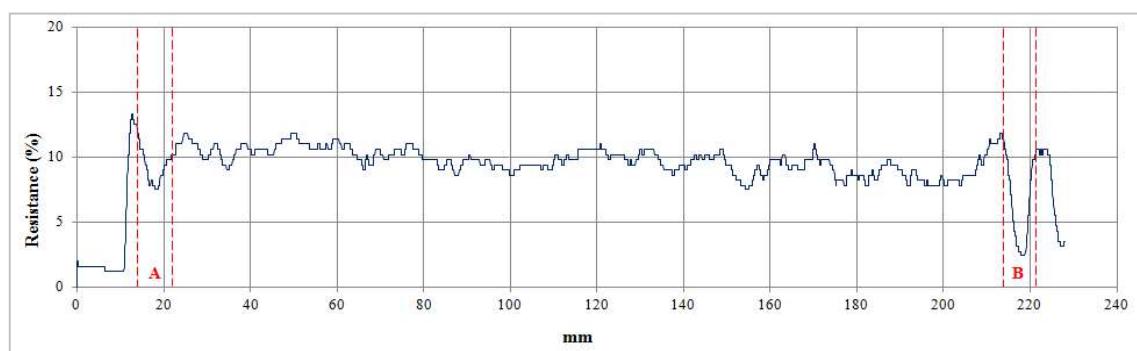
**Figure 45.** Resistograph profile of a degraded element by house longhorn beetle

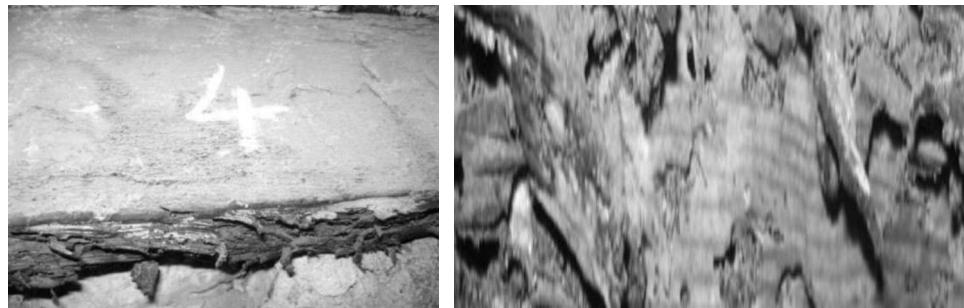
The subterranean termites were the most frequent biological agent on the storeroom roof. The attacked elements by these insects show galleries or “shelter tubes” made of soil through which

they reach their source of food (Figure 9). In this elements neither insects nor swarms were found. The most severely attacked element had an effective cross section reduction of 12,8%.

Figure 46. Biological damage caused by subterranean termites

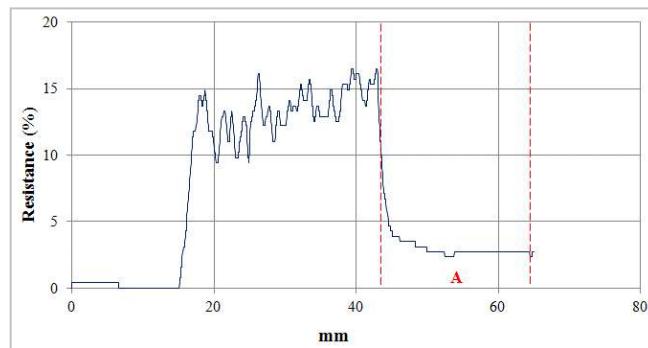
The following resistographic profile shows that almost half of the timber element is degraded by subterranean termites (Figure 10). Since verified moisture content values were below 20% the termite attack had ceased to exist, not requiring any treatment.

Figure 47. Resistograph profile of a degraded element by subterranean termites

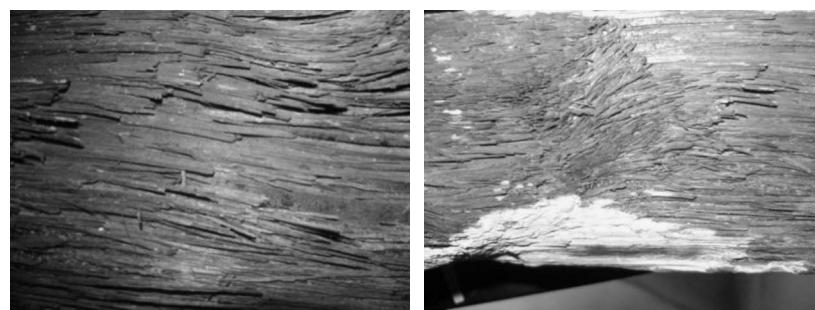
In this area it was also verified biological degradation by white rot fungi. The degraded element has a fibrous appearance, with transversal superficial shakes (Figure 11). The current moisture content does not allow the development of this kind of biological agent. It is assumed that its occurrence may have been possible due to periods with an higher moisture content.

Figure 48. Biological damage caused by white rot fungi

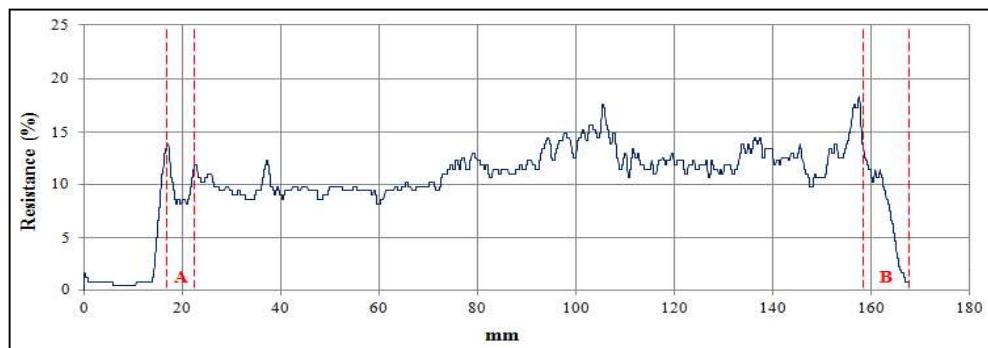
In the following resistographic profile (Figure 12) two areas with degradation by house longhorn beetle (A) and white rot fungi (B) were detected.

**Figure 49.** Resistograph profile of a degraded element by house longhorn beetle and white rot fungi

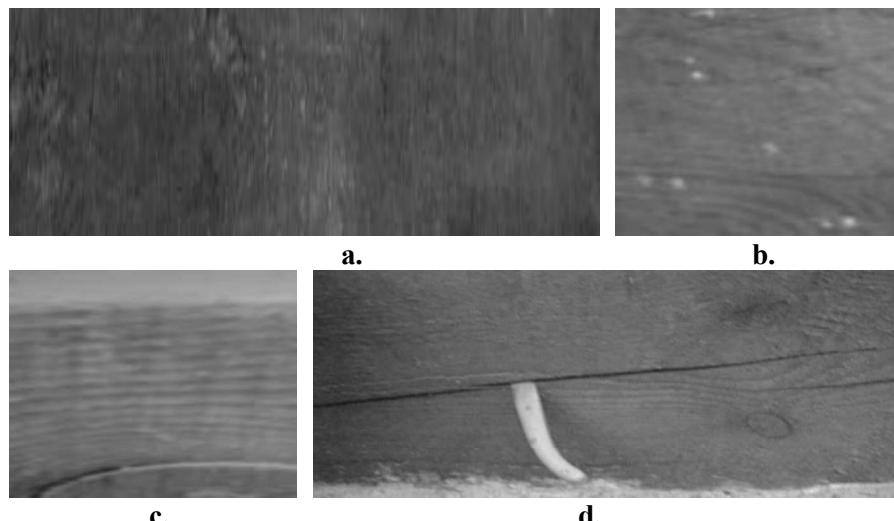
For both standards, the most influential and frequent verified defects were knots, cracks and slope of grain (Figure 13).

**Figure 50.** Timber defects: wane (a), knots (b and c) and cracks (d)
