ASSESSMENT OF A TIMBER STRUCTURE IN THE “ERMIDA DA ASCENSÃO DE CRISTO” IN LISBON

Diana Araújo^{1*} and Dulce Franco Henriques¹

Keywords: Timber structures, assessment, degradation, grading rules, strength classes, critical section

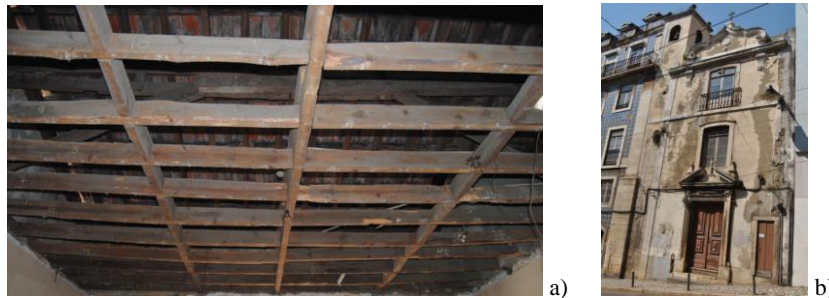
Figure 1. a) Ceiling structure b) Chapel's facade

In this structure were visually assessed 28 beams (Figure 1 a.). Biological degradation caused by wood boring insects with larvae commonly known as woodworms of the species of *Hylotrupes bajulus* (House longhorn beetle) and *Anobium punctatum* (Common furniture beetle) was found. The degradation by the last one was signed by the presence of small and numerous holes in the surface of 13 beams (Figure 2 a.). The degradation by *Hylotrupes bajulus* was observed by the presence of sawdust in large quantities compacted inside the galleries and the big holes with elliptical shape [6], as well high section losses that compromised the structural condition of some beams (Figure 2 b.).

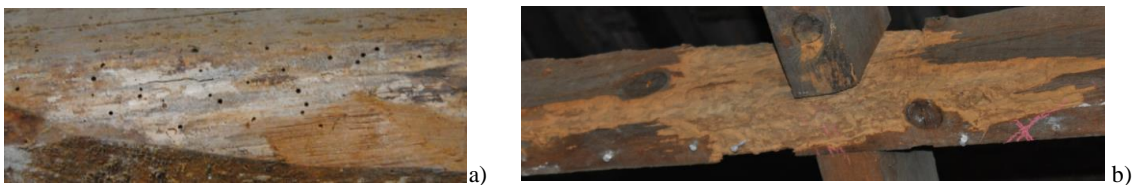
Figure 2. a) Biological degradation caused by *Anobium punctatum* b) Biological degradation caused by *Hylotrupes bajulus*

In general way, some structure elements have significant loss of effective sections, with a maximum value of 39%, comparing to initial section. This loss of section is caused just by wood boring insect (*Hylotrupes bajulus L.*), without evidence of rot fungi. On a posterior step, it will be necessary to determinate with more precision residual sections, that will allow the results maintenance, and consequently the safety' users and the structure itself. It is also important to refer poor condition of joints and supports that, apart from biological damage also have gaps and misalignment to the pieces axis. In a rehabilitation solution, supports must be reinforced, 3 beams must be replaced and 7 must be reinforced, if it wants to use the attic.

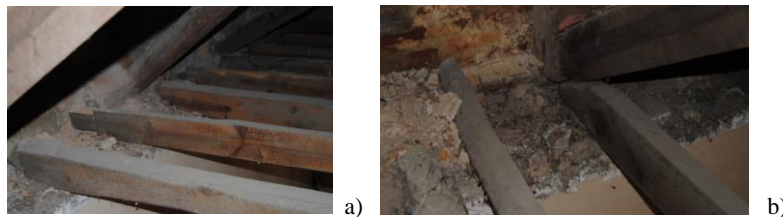
The rate of growth was the most complex parameter to determine because the measurements had to be made on the top of the pieces or in the faces where the presence of pith is visible. Almost all the tops are against the walls (Figure 7 a. and b.), so the observation was not allowed and that ones that were not, were really dirties, so it was not possible to count the growth rings. However, 7 of the 27 analyzed beams had pith on their faces, so only this beams were assessed. The partial results are in table 1.

Figure 6. a) and b) Beams' ends

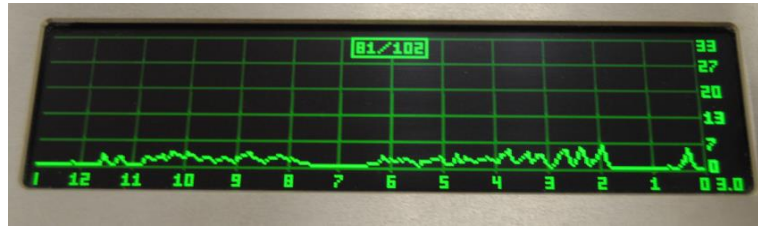
In this test was possible to determinate nonexistence of residual section in 2 beams in study.

The needle's device passed through all section without any type of resistance (Figure 8), what leading to believe that section is not composed by really sound wood, but mainly for degraded wood, that only keeps cohesion and enough resistance to maintain the position of the element.

Figure 7. Drill resistance profile
