Article

Understanding Structural Timber in Old Buildings in Lisbon, Portugal: From Knowledge of Construction Processes to Physical–Mechanical Properties

Citation: Henriques, D.F. Understanding Structural Timber in Old Buildings in Lisbon, Portugal: From Knowledge of Construction Processes to Physical–Mechanical Properties. *Buildings* **2025**, *15*, 1161. <https://doi.org/10.3390/buildings15071161>

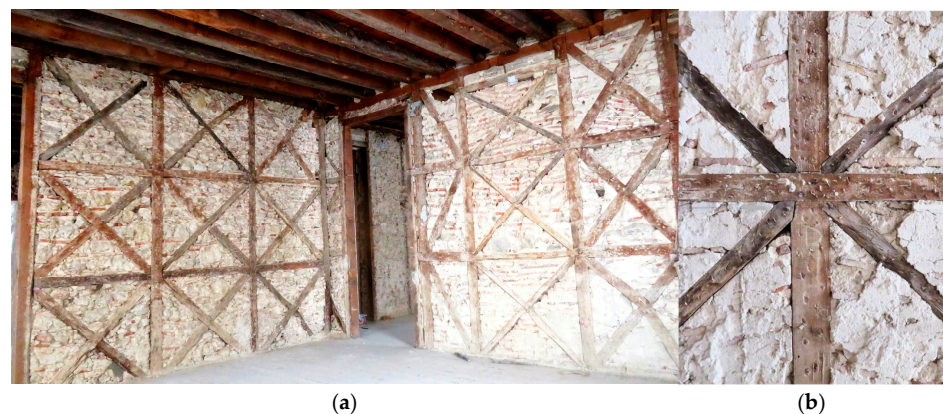
Figure 2. Examples of ‘frontal’ walls in view and in detail. (a) ‘Frontal’ walls in an 18th century building (source: author’s collection); (b) detail of a ‘frontal’ wall knot with chipped timbers (source: author’s collection).

The ‘frontal’ walls are a mixed construction of made of vertical and horizontal wood elements braced with diagonals named St Andrew’s Crosses with masonry infilled [13]. At the second quarter of VIII century, they became the main internal dividing walls of housing buildings. The most common type of construction is the woven front, made up of (0.10 to 0.15) m × (0.08 to 0.10) m sectional beams, fitted and nailed to the floor, and ceiling joists at a distance of around 1 m [4]. The formation of triangles by the St Andrew’s crosses guarantees the structure’s inability to be deformed and its ability to withstand an earthquake [14,18,26]. The height of the ceiling is divided into equal parts and horizontal beams are laid plumb to plumb. Diagonal struts are inserted in the rectangles formed between the props and the beams (Figure 2). The beam located under the floor joist is also known as a ‘frechal’ [15].

To improve the adhesion and function of the joint between the coating mortar and the wood, the surface of the wood faces was chipped (Figure 2b) and the fascias were nailed at intervals to create an uneven surface through which the mortar was introduced. This joint is essential to ensure the mobilisation of shear strength between materials with such different physical–mechanical properties [15]. Fascias were used to finish the front walls, partitions or ceilings (Figure 3).

The so-called simple partition generally consisted of a series of planks, not cleaned or planned, on the inside, spaced at least 1 cm apart and nailed at the top to rails fixed one to the floor and the other to the ceiling. Orthogonally, the trapezoidal fascias are nailed with their smaller side to the partition boards [15,31,32], shown in view and in detail in Figure 2.

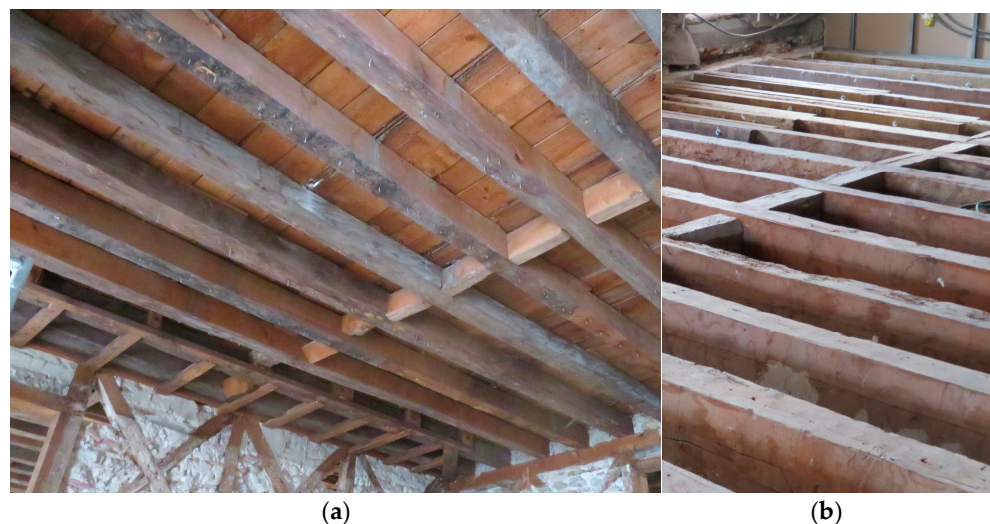
Figure 4. Floor beams, properly doweled (source: author's collection). (a) View of the floor structure resting on 'wall plate' after the ceiling has been removed; (b) Floor structure after the floor has been removed.

The floor system consists of parallel main beams, with a spacing of 0.30 to 0.40 m, as evidenced in meticulously constructed buildings. During the 19th century, however, building practice moved towards narrower beams with greater spacing (0.50 to 0.60 m) [4].

The floors were attached to the beam by means of small crosspieces, fitted in a straight line and nailed to it, with a height equal to that of the beam (Figure 4). Their function was to prevent the beams from buckling or swaying and to lock them in place. For spans of 4 m or more, a spacing of half the span was used, and for longer spans, spacing every 2.50 m was used [33].

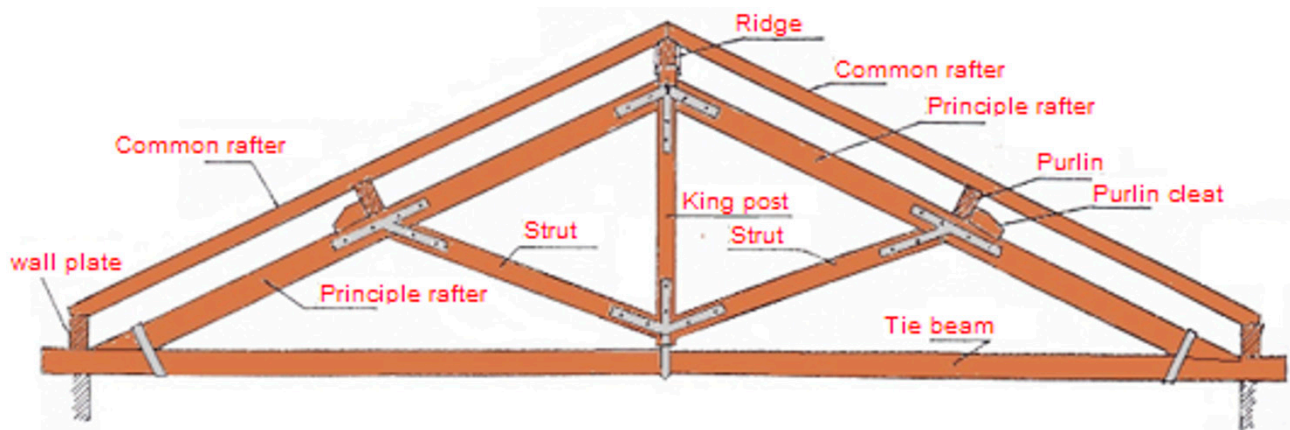
Figure 5. Representation of a traditional King post roof truss (source: adapted from [33]).

In the simplest cases, trusses are made up of a triangular set of different elements called rafters, struts, purlins, the tie beam and the king post (Figure 5). In the simple roof trusses, the tie beam is always horizontal, rafters connect on the tie beam in an inclined position to form the roof slopes, the king post is clamped vertically by the struts at the apex of the roof and the struts are inclined and connect the legs to the pendant. In single-member trusses, the most prevalent rafter and tie-beam carpentry connection is the 'front notch connection', which involves a V-shaped indentation in the upper face of the tie beam, wherein the notched end face of the rafter is positioned [32,34].

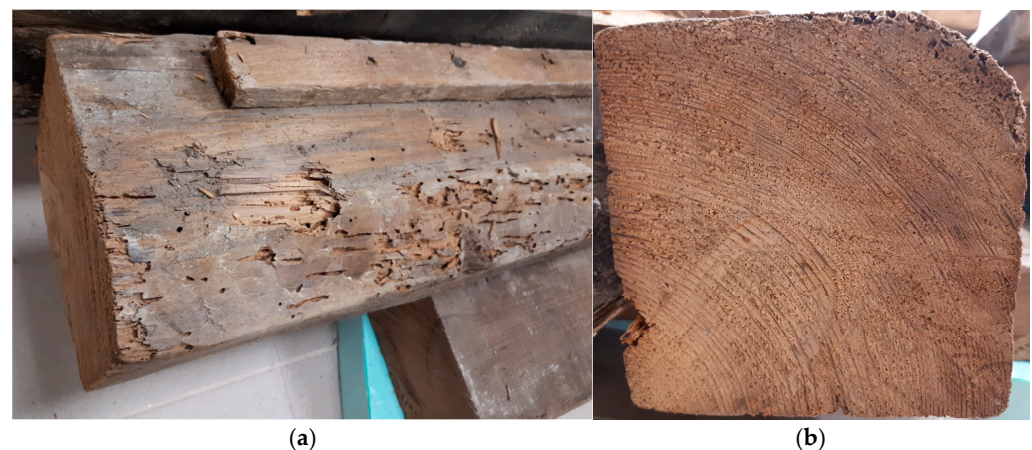
Figure 6. Structural element degraded by woodworm (source: author’s collection). (a) External appearance of structural element; (b) internal appearance of section.

- Woodworm or beetle damage—This is usually found along the entire length of the element, with the main signs being holes in the surface (round and numerous in the case of small woodworms, and oval and few in the case of large woodworms) and sawdust pushed outwards in the case of small woodworms [9,38]. Often, especially in the case of large beetle infestation, this is only superficial, and it is possible to identify the area of galleries by identifying a section of healthy wood underneath. Figure 6 shows one of these cases with a beam from a ‘Pombaline’ building: although the external appearance is considerably degraded by small woodworms (Figure 6a), the degraded layer is only a few millimetres deep (Figure 6b) [38]. The reduction in the wood’s resistance is the result of a physical reduction in the cross-section of the material due to the opening of galleries by the larvae. If the galleries are at a shallow depth, a reduced (effective) cross-section can be estimated [12]. In other cases, the attack may take the form of diffuse damage to the cross-section, mainly in the sapwood, with no apparent loss of the cross-section. In these cases, a reduction in mechanical properties and density can be expected [12,39,40];

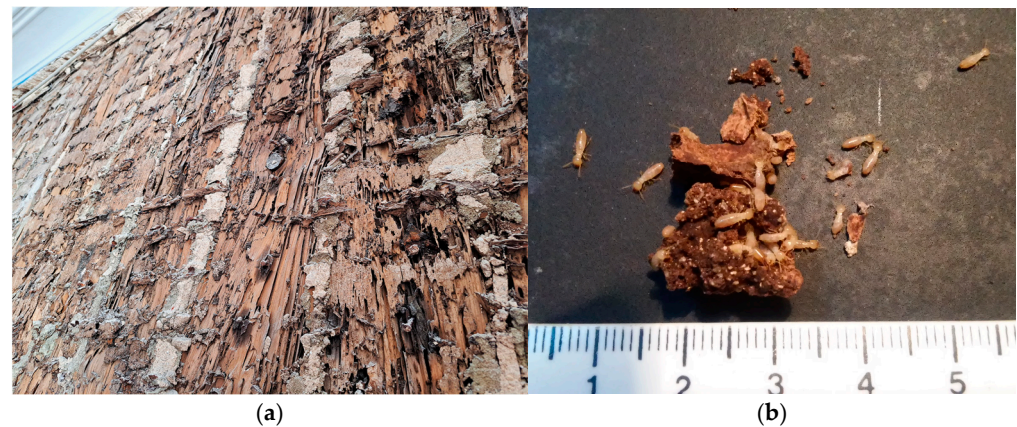
Figure 7. Appearance of wood degraded by subterranean termites (source: author's collection). (a) Decayed partition wall along its entire length after cladding has been removed; (b) Subterranean termite (removed from habitat) appearance and size.

- Subterranean termite (*Reticulitermes grassei*) attack—This occurs only in damp wood and is more common in areas of rising humidity, in contact with the ground or under gutters. The wood is veneered and usually has earthy concretions inside (Figure 7a,b).

Subterranean termites eat away at the wood under an intact surface, but without any resistance to the tip of a sharp object, causing a significant physical loss of material throughout the section, which almost always results in the complete replacement of the damaged parts [9,33,38].

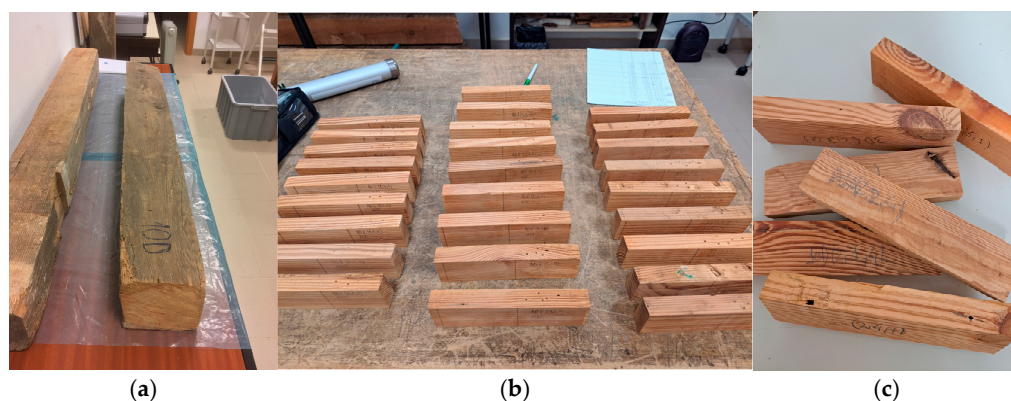
Figure 9. Laboratory material for testing (source: author’s collection). (a) Two of selected beams; (b) some of selected specimens; (c) example of unsuitable specimens.

From a set of wooden structural elements collected from Pombaline buildings in the Lisbon region, five beams of Scots pine (*Pinus sylvestris*, L.) were selected (Figure 9a). They were then cut into $25 \times 55 \times 200$ mm specimens and stabilised in a conditioned atmosphere at $RH = 65 \pm 5\%$ and $T = 20 \pm 2$ °C [23]. Following the process of stabilisation, the mass and dimensions of each specimen were measured, and their density was calculated based on an average water content of 12% (Figure 9b).

As the beams were old and had been cut by hand, there were many irregularities on the faces, as well as some cracks, biological deterioration and iron nails. All specimens with any defects were considered unsuitable for testing (Figure 9c). Therefore, prior to the tests, approximately two thirds of the cut specimens were rejected. So, 68 specimens were considered suitable for testing [24].

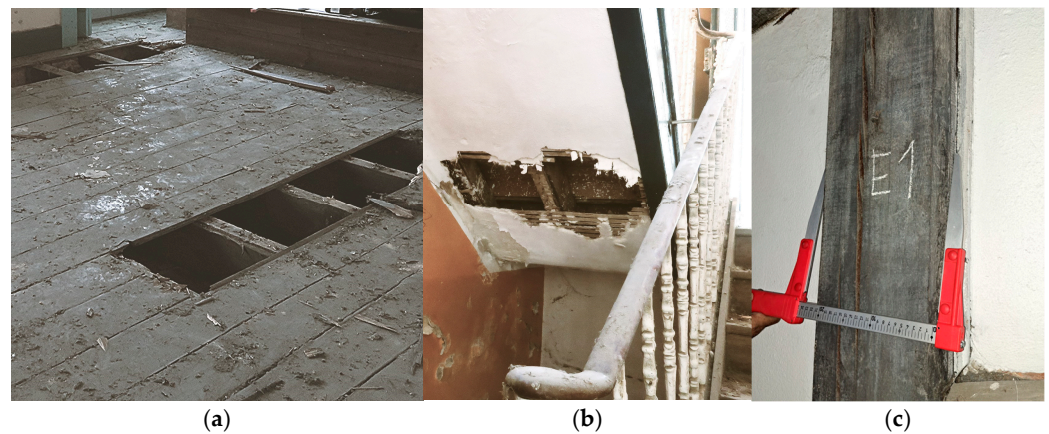
Figure 10. In situ tested members (source: author's collection). (a) Floor beams; (b) staircase rafters; (c) column.

The in situ tests are the central objective of this project, because the aim of this study is to find a pattern that can be used in practical situations. The campaign was carried out in different old buildings. In each building, the elements tested had different functions, such as floor beams, columns, staircase beams and others. As such, they were subjected to different types of loads (Figure 10a–c).

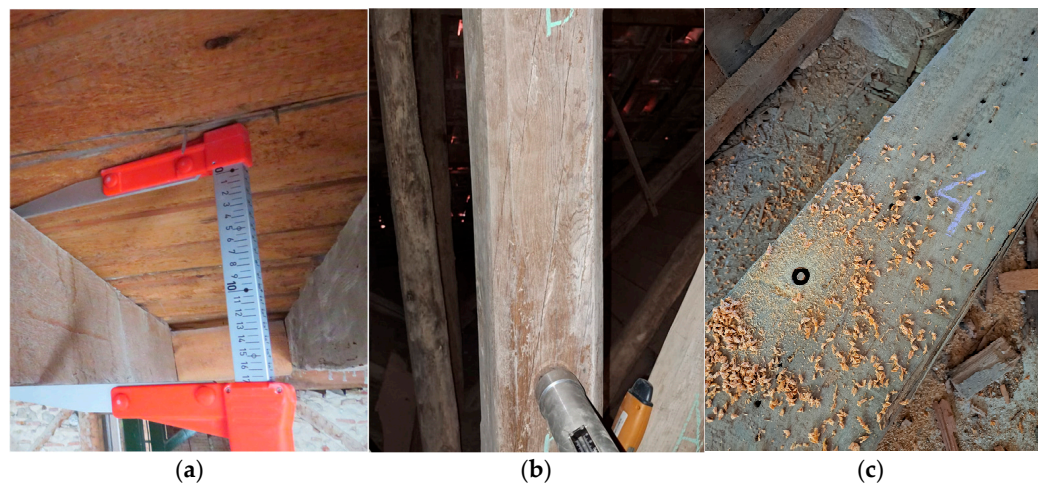
Figure 11. In situ inspection procedures (source: adapted from [33]). (a) Geometric survey of the timber elements; (b) resistance to penetration test; (c) core extraction.

- The determination of the water content of the wood element, as well as the RH and temperature values at the test locations.
- The identification of the geometric conditions and state of conservation of the structural elements (Figure 11a).
- The characterisation of the surface's hardness with Pilodyn® (Figure 11b).
- Wood core extraction for the laboratory study and the correlation with values estimated indirectly from Pilodyn® measurements (Figure 11c).
- Eighteen wood cores in good condition, 7 mm in diameter and up to 120 mm long, were extracted for this study in the vicinity of the resistance to penetration tests.

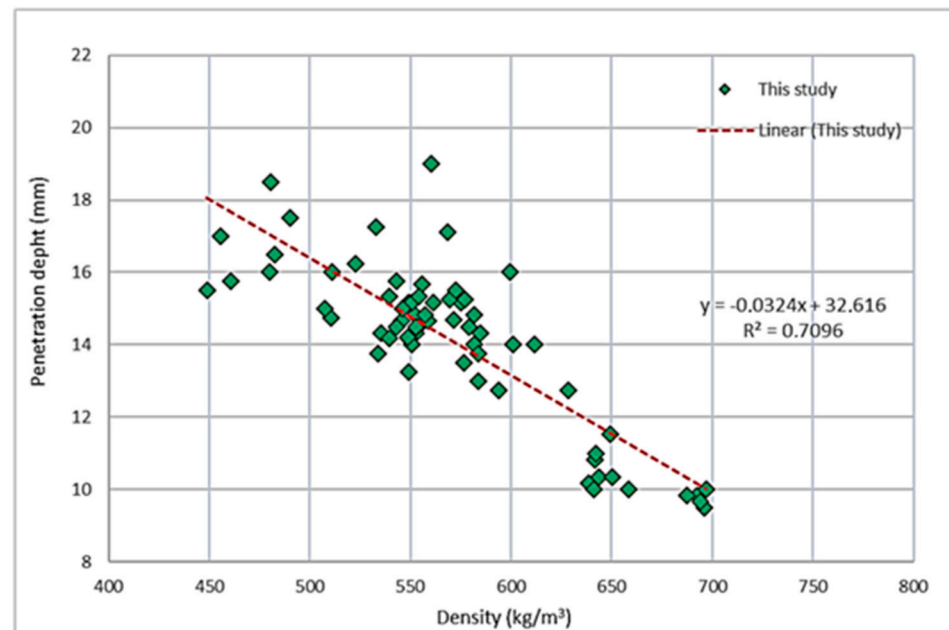
A scatter plot was constructed utilising the mean of six penetration depth measurements and the density of each specimen ($n = 68$). A linear correlation was identified as the most suitable fit for the observed outcomes. The calculation of the correlation gave a coefficient of determination (R^2) of 0.71, indicating a reasonable to good relationship for the wood material (Figure 12)

Figure 12. Results of penetration resistance versus density.

The correlation between density and the Pilodyn readings is presented in Equation (1)

$$Depth_i = -0.0324 \rho_i + 32.616 \quad (\text{kg/m}^3) \quad (1)$$
