# 9<sup>th</sup> International Symposium on the Conservation of Monuments in the Mediterranean Basin

## INSPECTION AND DIAGNOSIS OF TIMBER STRUCTURES BY NON-DESTRUCTIVE METHODS

The case study, named Palacete Ribeiro da Cunha, is located in Príncipe Real (Lisbon, Portugal) and his design is from 1877.

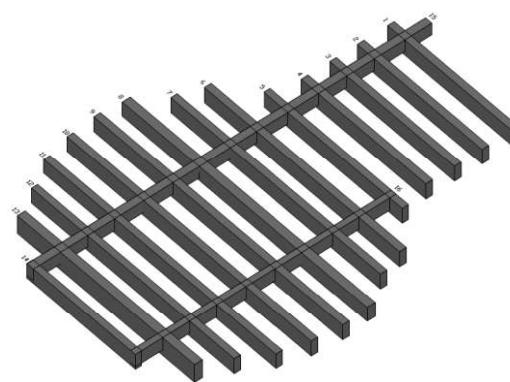
**Figure 40.** Bathroom pavement structure (joist and blockings)
