ASSESSMENT OF A TIMBER STRUCTURE IN THE “ERMIDA DA ASCENSÃO DE CRISTO” IN LISBON

Diana Araújo^{1*} and Dulce Franco Henriques¹

Keywords: Timber structures, assessment, degradation, grading rules, strength classes, critical section

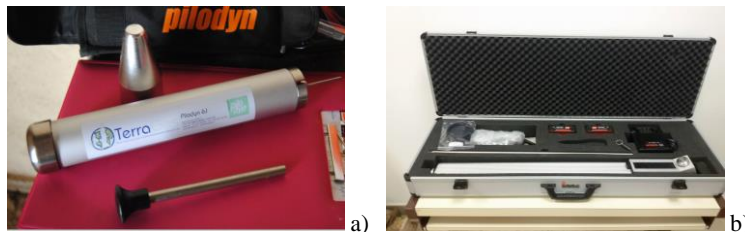
To this test was used a *Pilodyn*®, model 6J (Figure 4 a.), being that on sound beams were made ten tests in the extension of the beams, and on beams with some kind of degradation were made the same ten tests and five more on the degraded area.

Was used a drill resistance test device, model IML Resi PD 500 (Figure 4 b.), working with *Pilodyn*®, on the same sections of the element. Was followed this logic by the necessity of crossing values and informations of both devices to obtain maximum information about the section under study. The tests were conditioned for the disposal of the elements and the space between beams, having the device been positioned always in the vertical way, and the test was realized from the lower face of the beams.

Figure 4. a) Impact resistance test device: *Pilodyn*®- Model 6J b) Drill resistance test device: Model IML Resi PD 500
